## OVERVIEW

UMS Group was engaged to perform an audit of the lat/long location of ~100,000 transmission structures on >1,000 circuits.

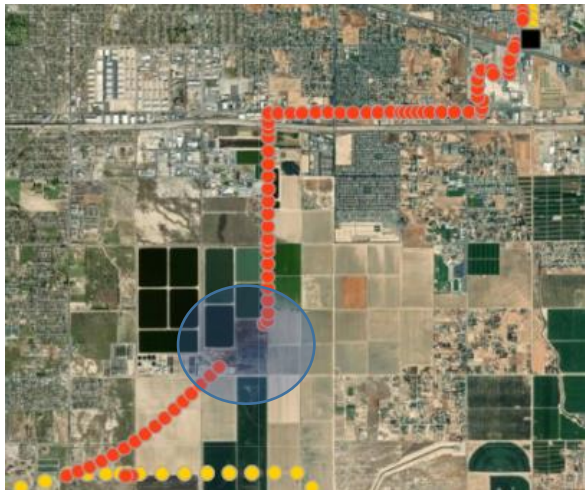
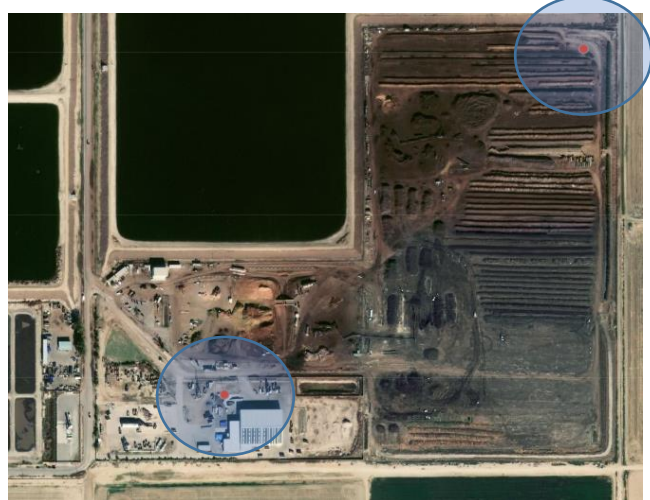
Example of the visualization of the Tx structure audit initiative

- This line would be noted as having an issue. There is a large gap between two structures (2500') that we could not find a logical reason for (i.e. guest line, highway/river crossing), Underground section, etc.
